## ***2.2 Effects of earthquakes on concrete buildings***

### *2.2.1 Global seismic response mechanisms*

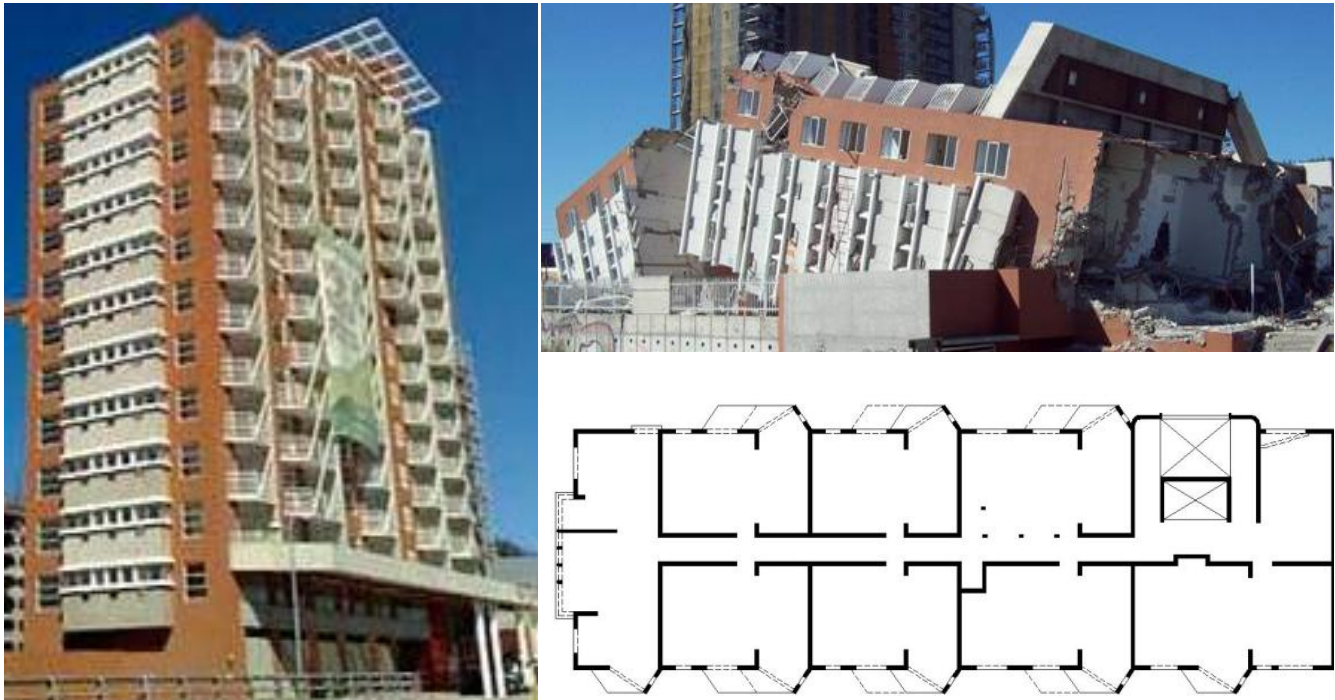
Fig. 2.13 Collapse of Alto Rio wall building in Concepción, Chile; February 2010 earthquake (structural walls are shown in black in the framing plan).

partitions. These walls were subjected to very high axial stresses due to gravity loads and failed at the lowest level in flexure-cum-compression, sometimes with lateral instability. A typical case is that of the building on the cover of this book, depicted in more detail in Fig. 2.13.

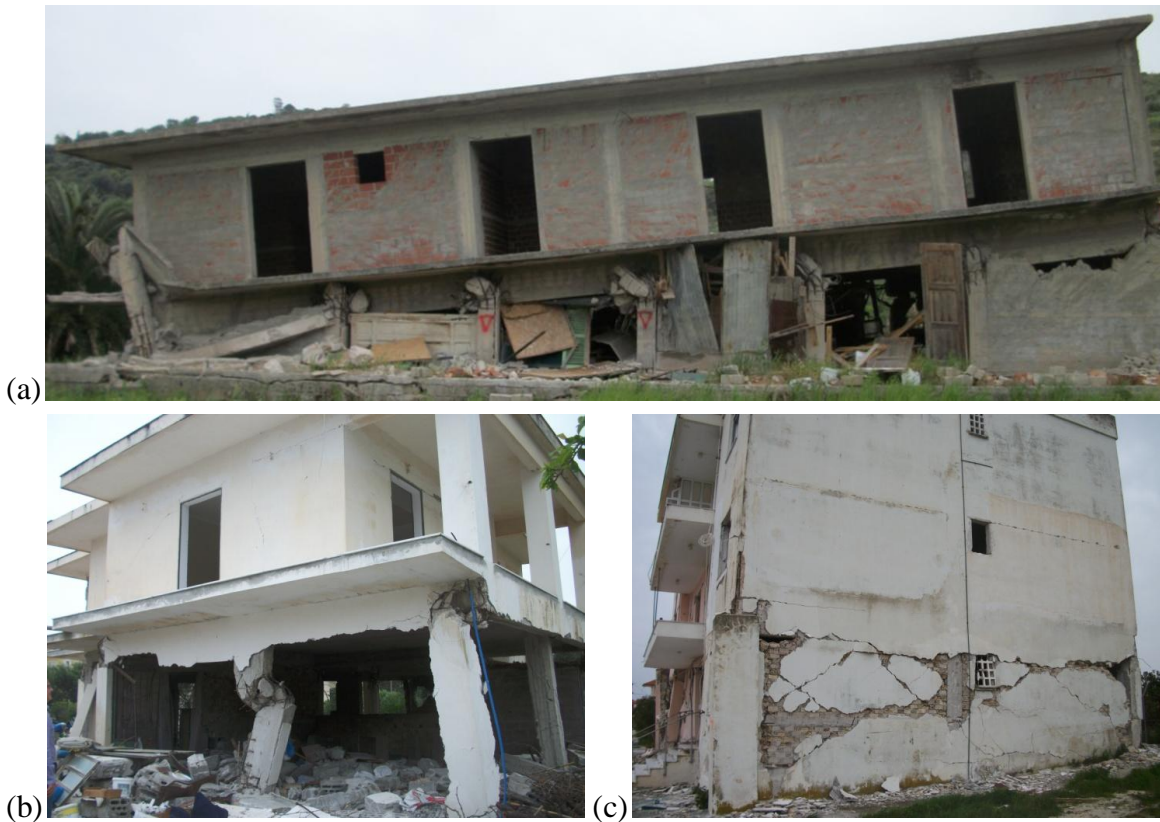
Fig. 2.14 Typical concentration of failures or damage in ground storey with role and damage to infills shown in (c).

In all the examples shown so far, as well as in Fig. 2.14, the ground storey was critical. Fig. 2.14(c) depicts the typical case of a concrete frame building with masonry infills, which have suffered heavy damage at the ground storey but may have saved the building from collapse. Figs. 2.10 to 2.14 may be contrasted to Fig. 2.15, where the top floors or an intermediate one have collapsed, but the underlying ones withstood both the earthquake and the collapse of the floors above. Such exceptions to the rule are most often due to an abrupt reduction in the lateral resistance of a floor, because that floor and those above were thought to be non-critical. Higher modes of vibration (see Section 3.1.4, 3.1.5), which are more taxing on certain intermediate floors than on the ground storey, may have played a role as well.

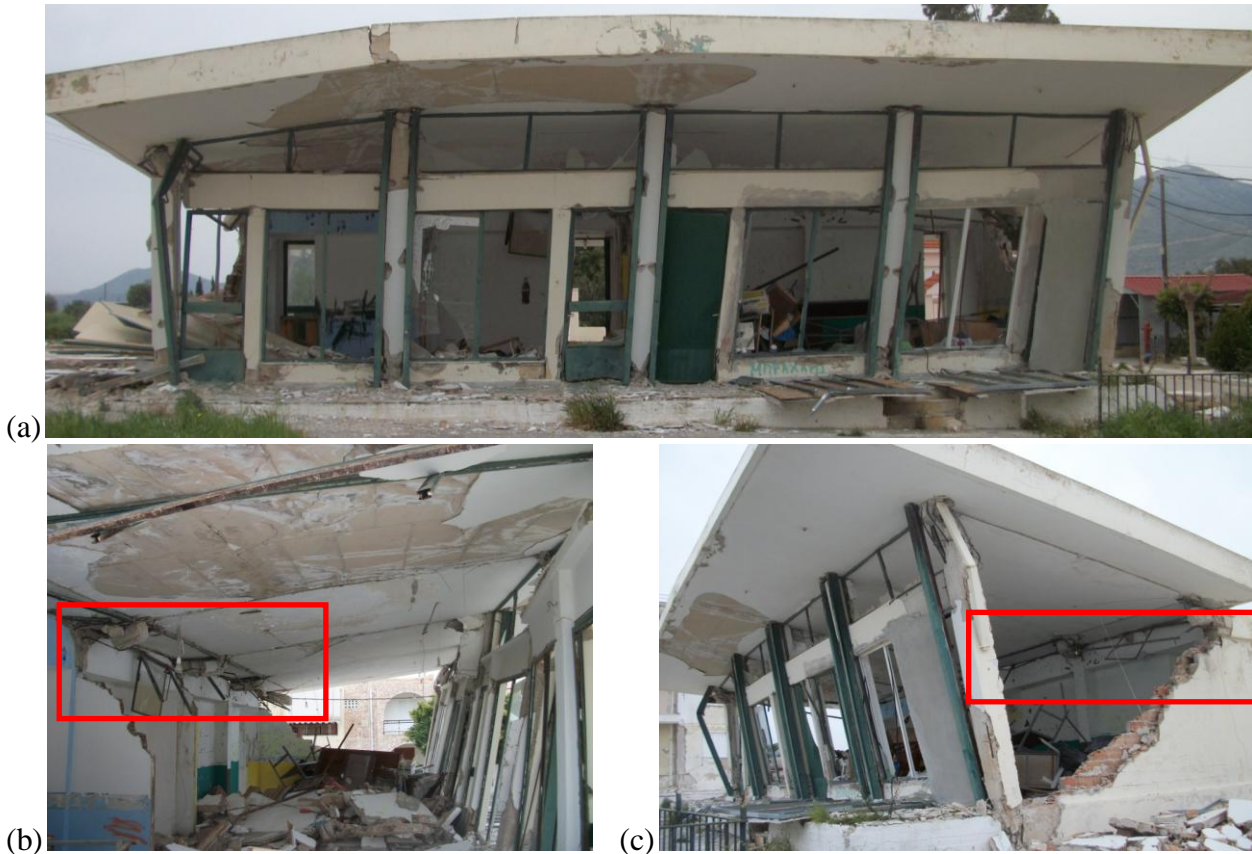
Fig. 2.17 Shear failure of short columns on stiff side (inside red rectangle) causes collapse of flexible side as well.

The collapse of the strongly asymmetric one-storey building in Fig. 2.17 demonstrates the opposite effect: calling the side in Fig. 2.17(a) as front, the vertical elements of the back side were shear-critical "short columns", developing higher shear forces than the columns on the front, owing to their much larger stiffness and short length. However, they did not have sufficient shear strength to resist these forces. They collapsed, pushing out the columns of the front side as well.

the secondary elements supported by the column between its two ends split its free height to two shorter ones. The back side columns in Fig. 2.17, whose failure triggered the global collapse of the building, were also short.

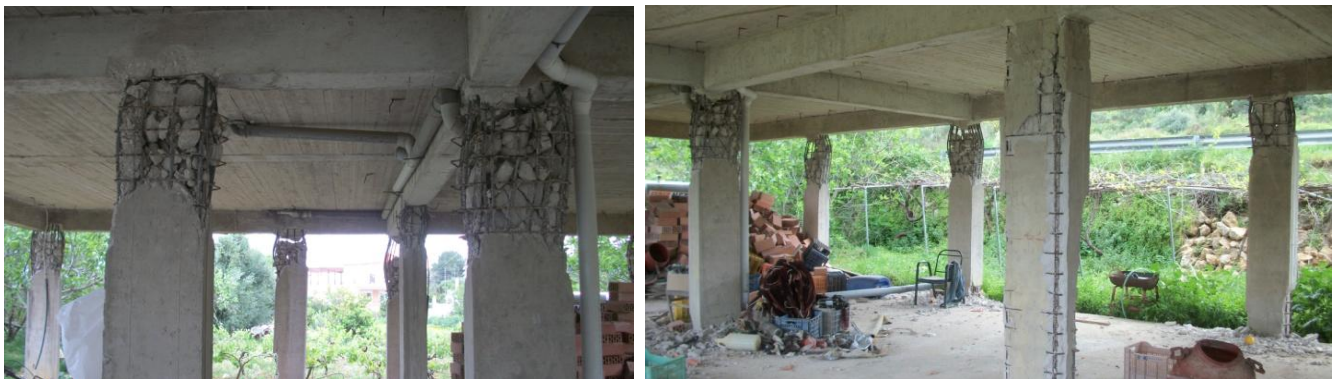
Fig. 2.20 Despite complete failure of columns across the ground storey, their residual axial load capacity still supports gravity loads.

Except for the one in Fig. 2.18(a), all columns in Figs. 2.18, 2.19 have essentially lost their entire lateral resistance and stiffness: they will not contribute at all against an aftershock or any other future earthquake. However, except for the column in Fig. 2.18(c), they all retain a good part of their axial load capacity. Note that the "quasi-permanent" gravity loads normally exhaust only a small fraction of the expected actual value of the axial load capacity of the undamaged column. On the other hand, the overlying storeys, thanks, among others, to their masonry infills, can bridge over failed columns working as deep beams. So, buildings with many failed columns or a few key ones in a storey are often spared from collapse. For example, very few columns were left in the building of Fig. 2.20 with some axial load capacity. Another example are the six storeys above the failed corner column in Fig. 2.21(a), which survived by working as a 6-storey-deep multilayer-sandwich cantilever beam, with the concrete floors serving as tension/compression flanges or intermediate layers and the infills as the web connecting them.

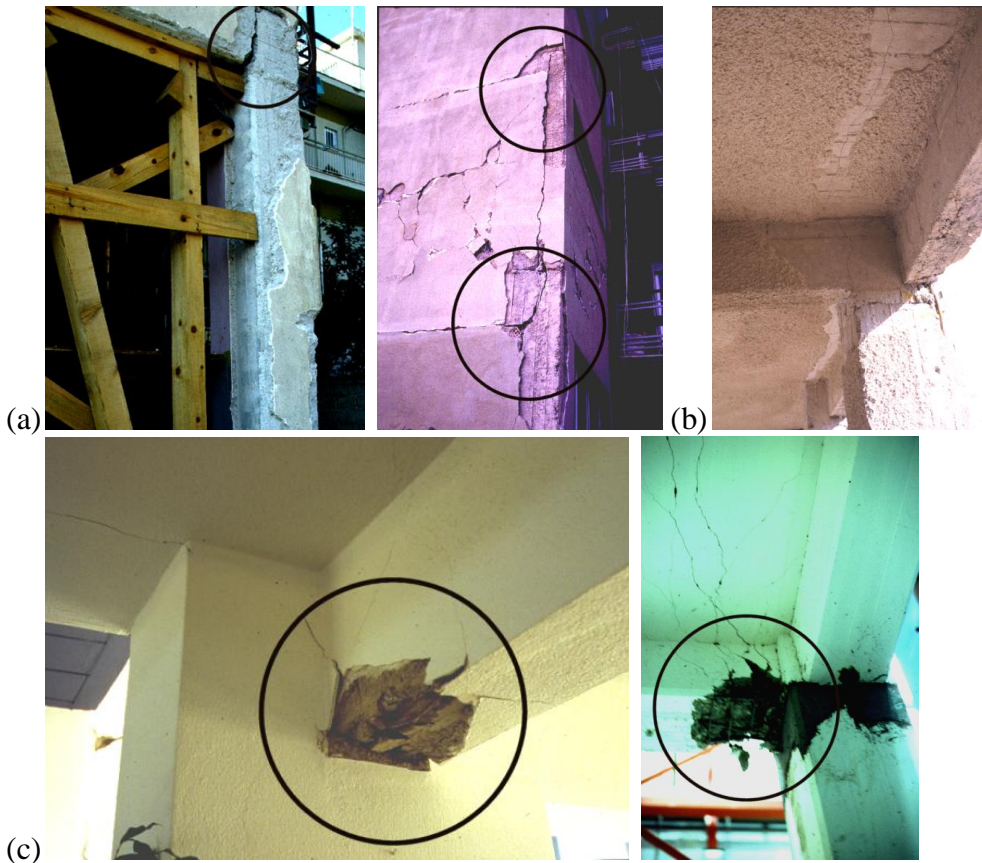
Fig. 2.22 Typical features of beam behaviour: (a) pullout of beam bars from narrow corner column, due to short straight anchorage there; (b) wide crack in slab at right angles to the beam at the connection with the columns shows the large participation of the slab as effective flange width in tension; (c) failure, with concrete crushing and bar buckling at bottom flange next to the column.

Beam bars with insufficient anchorage in a joint may pull out in an earthquake. Such a failure of bond and anchorage shows up at the end section as a crack through the full depth of the beam (Fig. 2.22(a)). A characteristic feature of a pull-out crack is its large width, well in excess of the residual crack width typical of yielding of the steel (which is a fraction of a mm or around 1 mm). The impact of this type of

angles to the beam, sometimes joining up with a similar crack from a parallel beam (Fig. 2.22(b)). The length and the sizeable residual crack width of such an extension show that the slab fully participates in the flexural action with its bars which are parallel to the beam, serving as a very wide tension flange.

Flexural damage is mostly associated with cracking and spalling of concrete and yielding of the reinforcement. By contrast, flexural failure comes with disintegration of concrete beyond the cover, often with buckling (or even rupture) of bars. Such effects (demonstrated in Fig. 2.22(c)) happen only at the bottom flange of a beam, because the slab provides the top flange with abundant cross-sectional areas of concrete and steel reinforcement. Larger amount of top reinforcement at the supports also result from the design for the hogging moments due to the factored gravity loads (the "persistent and transient design situation" of EN 1990). Note that a bottom reinforcement smaller than the top one, is unable to close the crack at the top face (as it is unable to yield the top reinforcement in compression): the vertical crack at the face of the support, across the full depth of the beam, tends to remain open and increase in width for each cycle of deformation; bottom bars may buckle and then rupture under the large cyclic excursions of strain across the open crack.
