# River Habitat Survey in Britain and Ireland

# CONTENTS

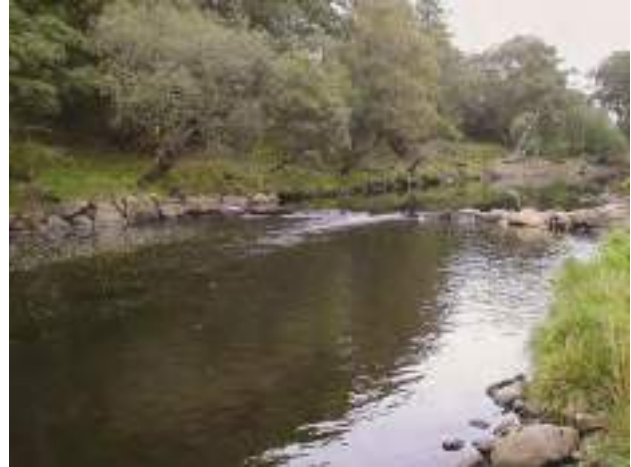
D1e Intermediate weir – boulders are not cemented, and water can leak through the fissures.

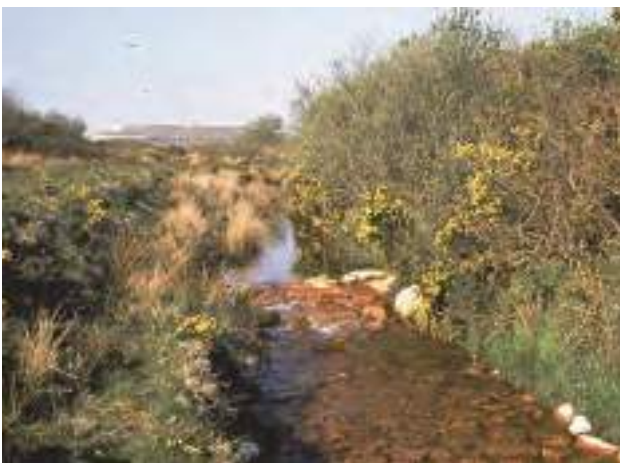
D1c Major weir/sluice – despite small size, the weir structure is ‘fixed,’ and does not leak water. Note scrub and short grass on right, and short grass and tussocky tall grass on left – both with simple bank vegetation structure. Water upstream is impounded.

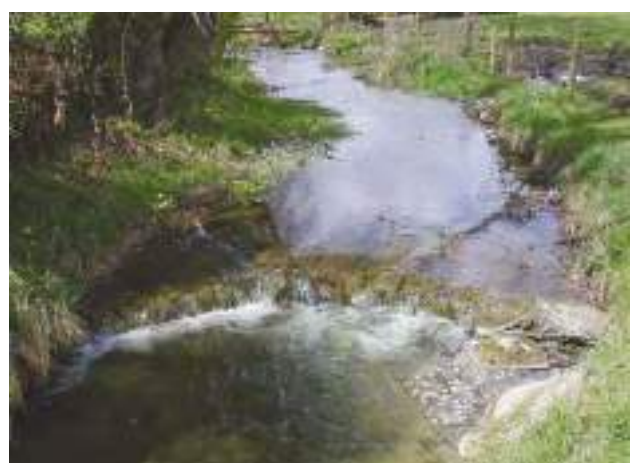
D1f Intermediate weir – wooden log construction, and water can leak through gaps.

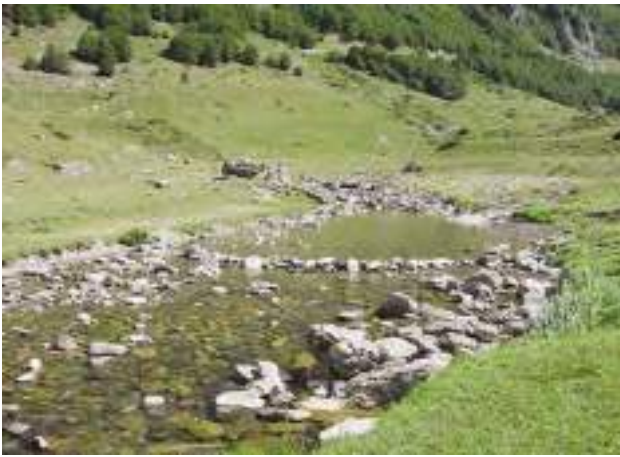
D1g Minor weir – a temporary structure; often built by children from boulders and cobbles.

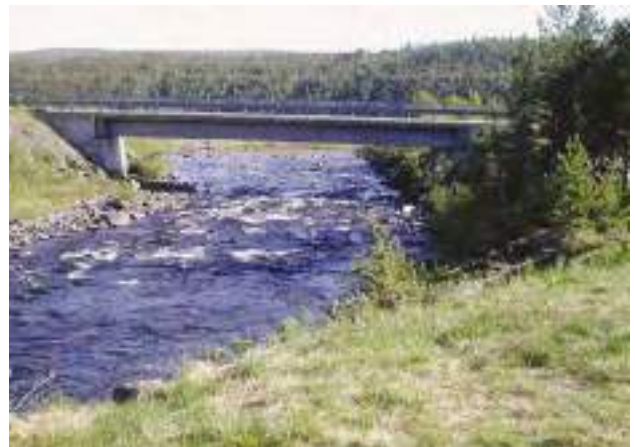
D3c Intermediate bridge – no central piers, and with bank-side abutments 10-25m long. Note broken standing waves.

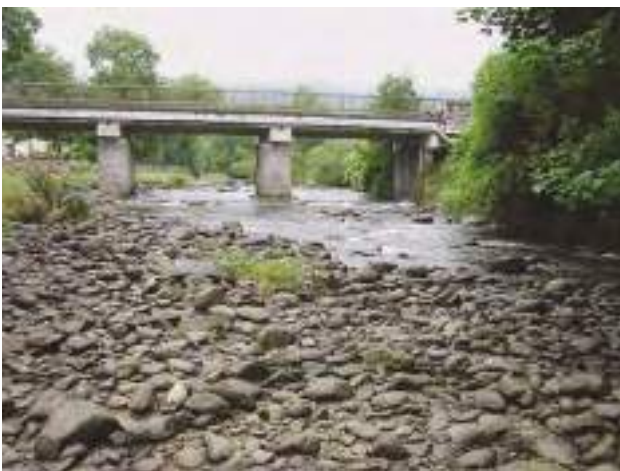
D3a Major bridge – all bridges with central piers are classed as ‘major’. Note importance of photographs to show size of piers, and degree of associated bed armouring. Classic cobble channel substrate exposed in foreground. See also D5b.

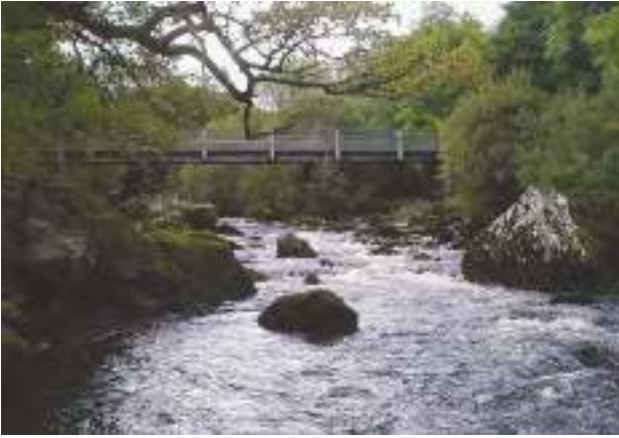
D3e Minor bridge – pipelines crossing rivers, if lacking central piers, are recorded as minor bridges. See also Na. Note exposed boulders and broken standing waves.

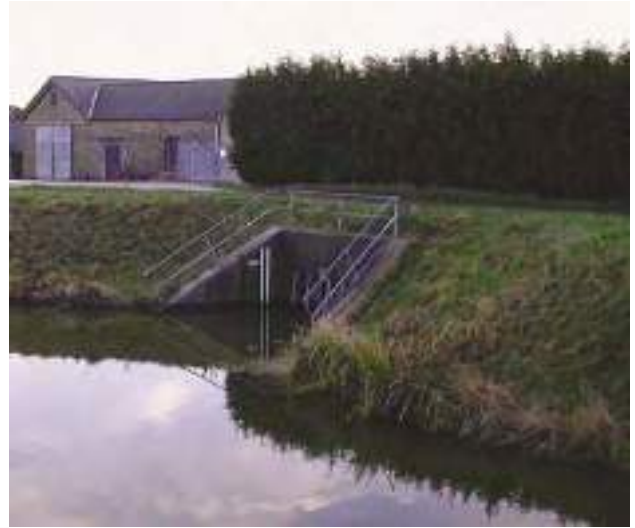
D4b An intermediate outfall, 10-25m long.

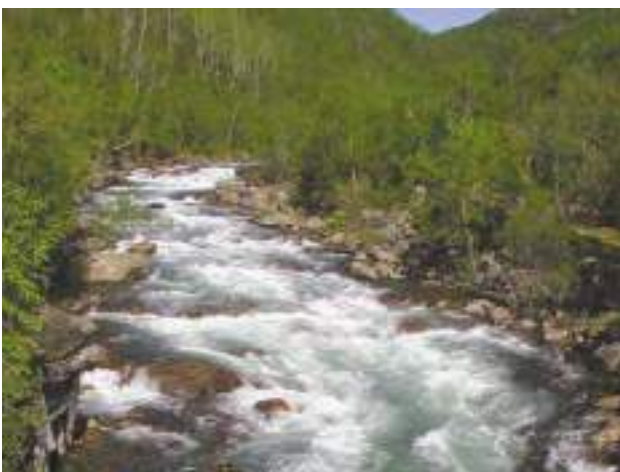
E1Ba Boulder bank material. Note broken standing waves.

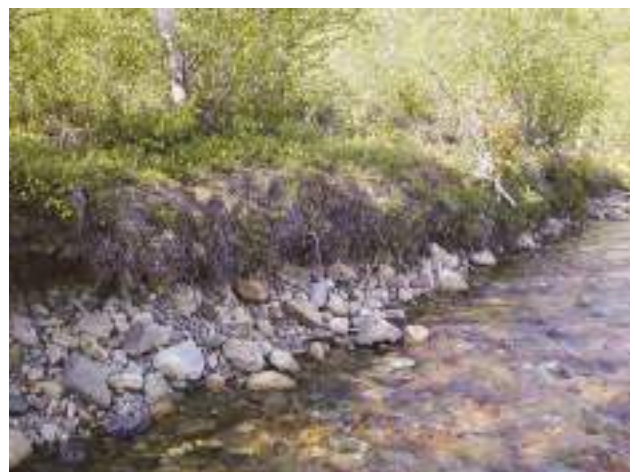
E1Cb Cobble bank material.

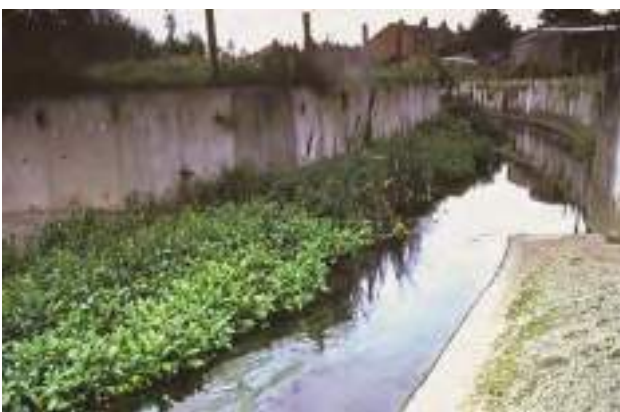
E1Hb Concrete bank material. This example illustrates an artificial berm as habitat creation as part of a flood defence scheme, and this should be noted in Section P.

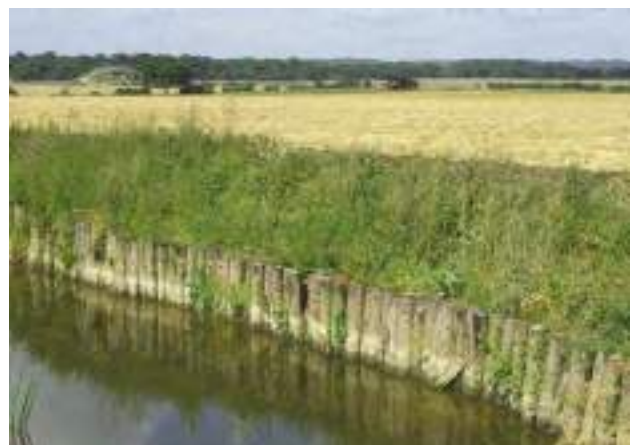
E1Jb Wood piling bank material – vertical poles below resectioned bank and arable (tilled) land-use in background.

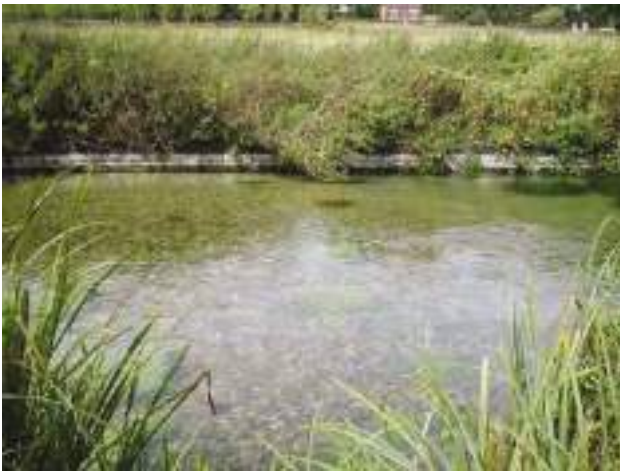
E1Oa Fabric bank material – non-degradable sheet ('nicospan'). Note tall herb bank vegetation above, so record structure as 'simple'.

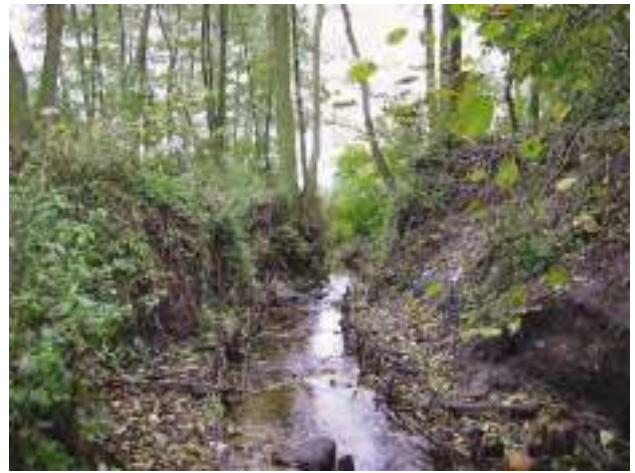
E1Pc Bio-engineering bank materials – woven dead stakes and twigs.

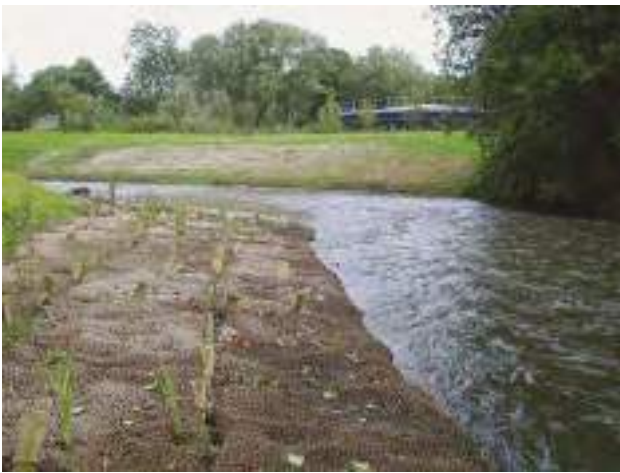
E1Pa Bio-engineering bank materials – bio-degradable matting with vegetation planting. Record bank vegetation structure as 'bare'.

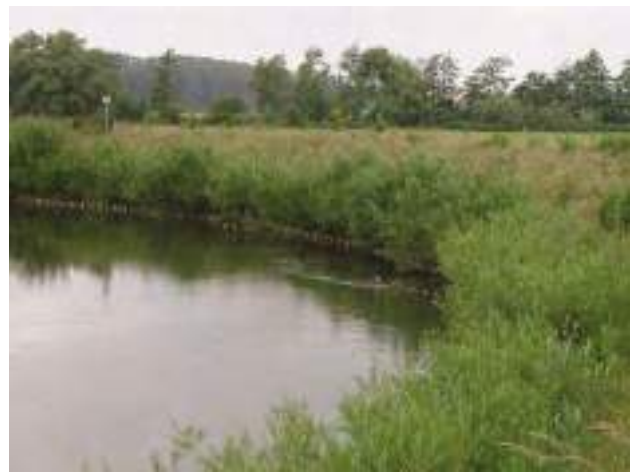
E1Pd Bio-engineering bank materials – live willow stakes. Bank vegetation structure is 'simple'.

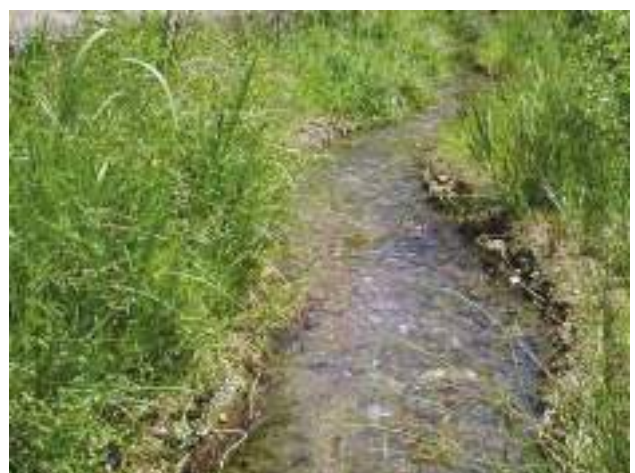
E1Pe Bio-engineering bank materials – here bio-degradable hessian has been used in combination with reed planting and other vegetation.

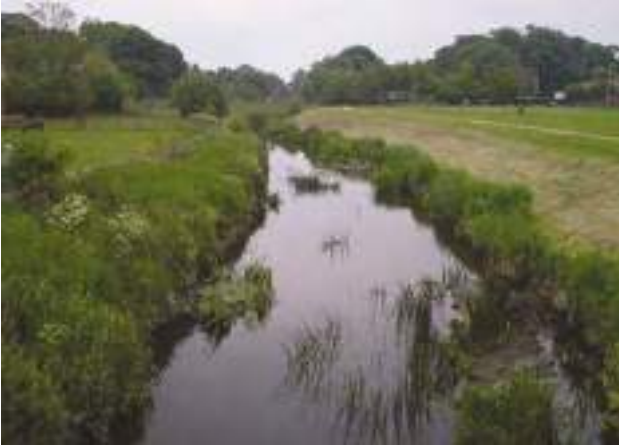
E2Aa Resectioned (reprofiled) bank – tell-tale smooth (trapezoidal) slope even though undertaken many years ago; river also over-deepened, with tell-tale ‘step’ in the profile where bed material at the base of the bank removed. See also A1a, D8a,b,c, E3Da, I6b.

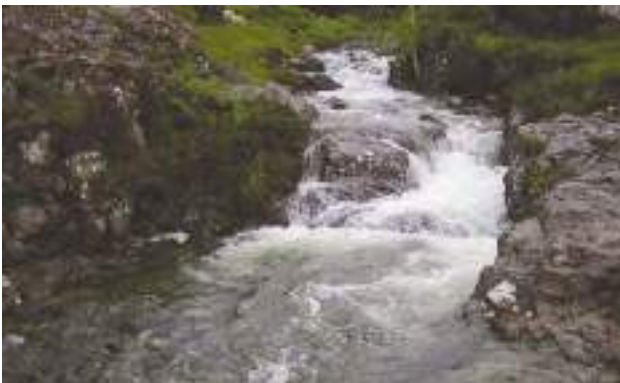
E5Ca Broken standing waves flow-type – typical turbulent white water waves. See also B3c, D3e, E1Ba, E4Ba.

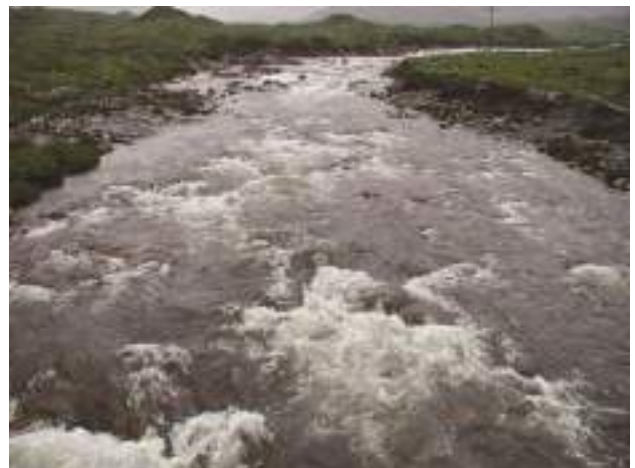
E5Cb Broken standing waves flow-type – typical turbulent white water waves.

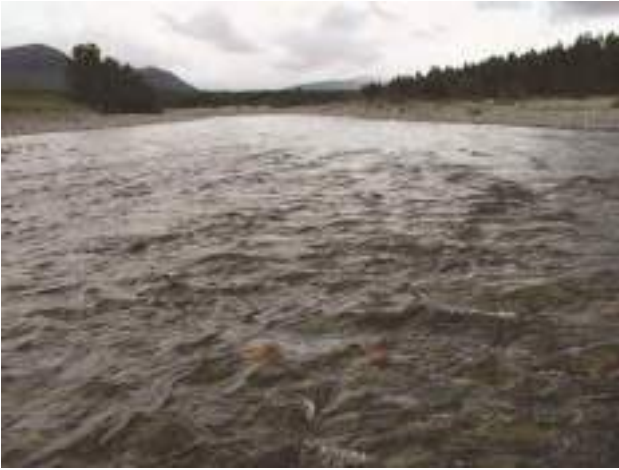
E5Da Unbroken standing waves – surface like 'dragon-back', but waves not broken. See also C1a,b.

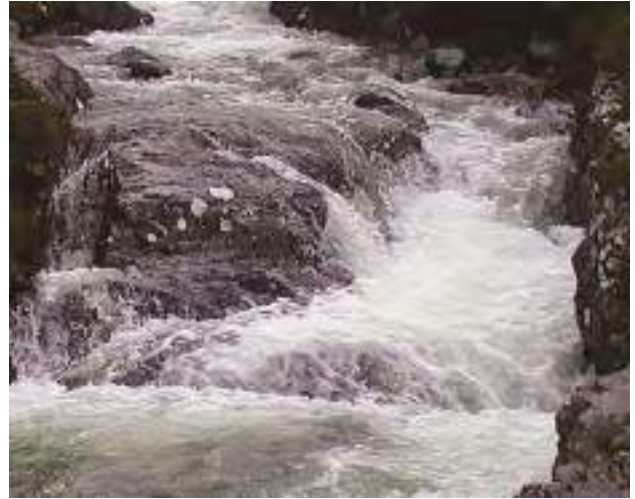
E5Ea Chaotic flow-type – Rare mix of three of the four most turbulent flow-types (free fall, chute, broken standing waves and upwelling) In centre of photo.

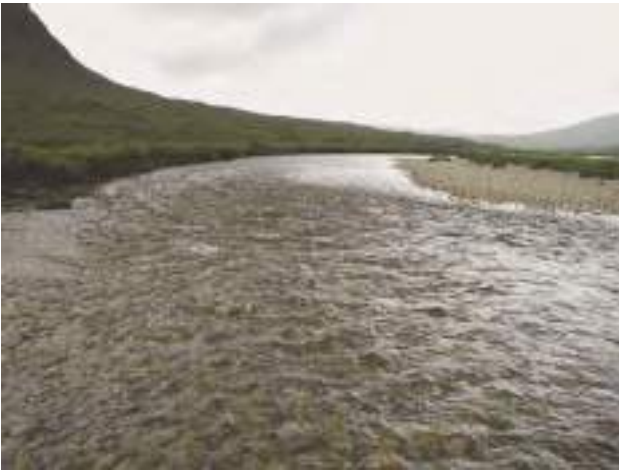
E5Db Unbroken standing waves – surface like 'dragon-back', but waves not broken.

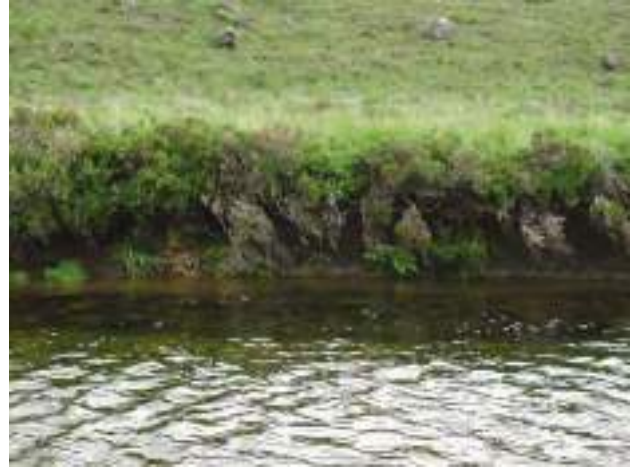
E5Fa Rippled flow-type – surface with small, symmetrical, ripples. Note uniform bank vegetation structure.

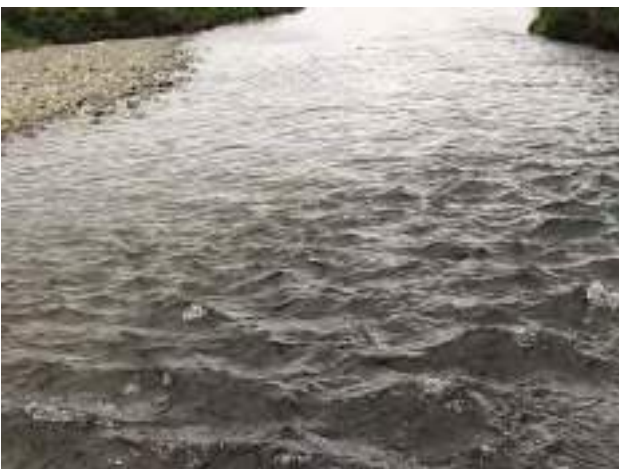
E5Dc Unbroken standing waves – surface like 'dragon-back', but most waves not broken.

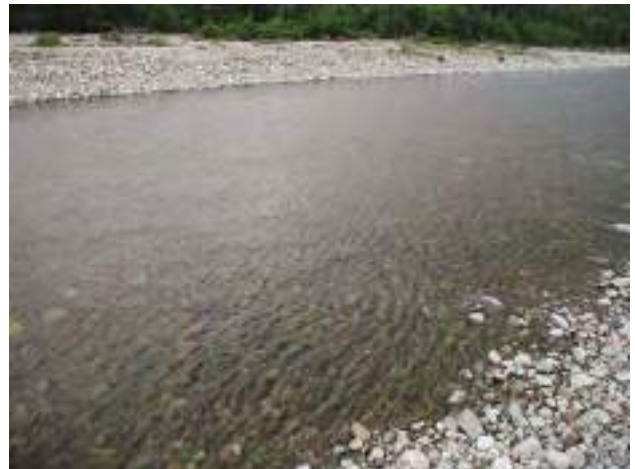
E5Fb BEWARE – appearance of 'Rippled flow-type' – surface with small ripples, but these are generated by wind action creating small waves.

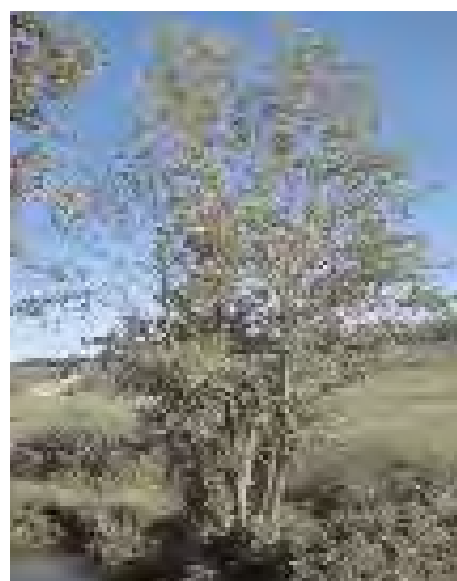
From a distance, diseased alders attract attention in mid to late summer because the leaves are frequently abnormally small, yellow and sparse (Figure 1). They often fall prematurely, leaving the branches bare. In a tree with severe crown symptoms, the lower part of the stem is often marked with a black or rusty coloured exudate known as ‘tarry spots’ which can sometimes occur up to 2–3 m from ground level (Figure 2). These spots indicate that the underlying bark is necrotic or dead. Over the next

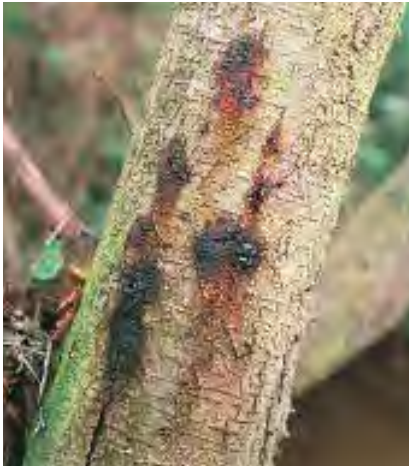
\*Previously Head of Pathology at Forest Research, now retired.

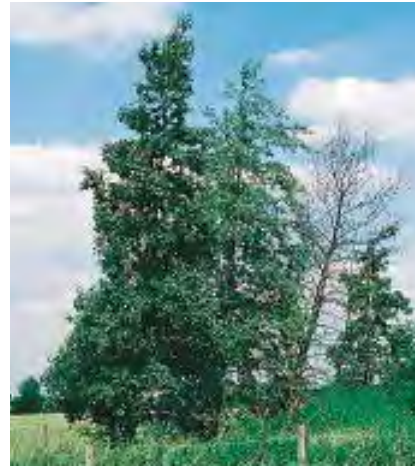
Most records of the alder *Phytophthora* have come from the common alder (*A. glutinosa*), but the fungus has also been detected in grey alder (*A. incana*), and Italian alder, (*A. cordata*; Figure 3). Recent work which has compared
